**U. S. STEEL MINNTAC
TWIN LAKES WILD RICE RESTORATION
OPPORTUNITIES PLAN
2016 ANNUAL REPORT**

DECEMBER 30, 2016

PREPARED FOR
U. S. STEEL MINNTAC
P.O. Box 417
MT. IRON, MN 55768

PREPARED BY
NORTHEAST TECHNICAL SERVICES, INC.
526 CHESTNUT STREET
Virginia, MN 55792

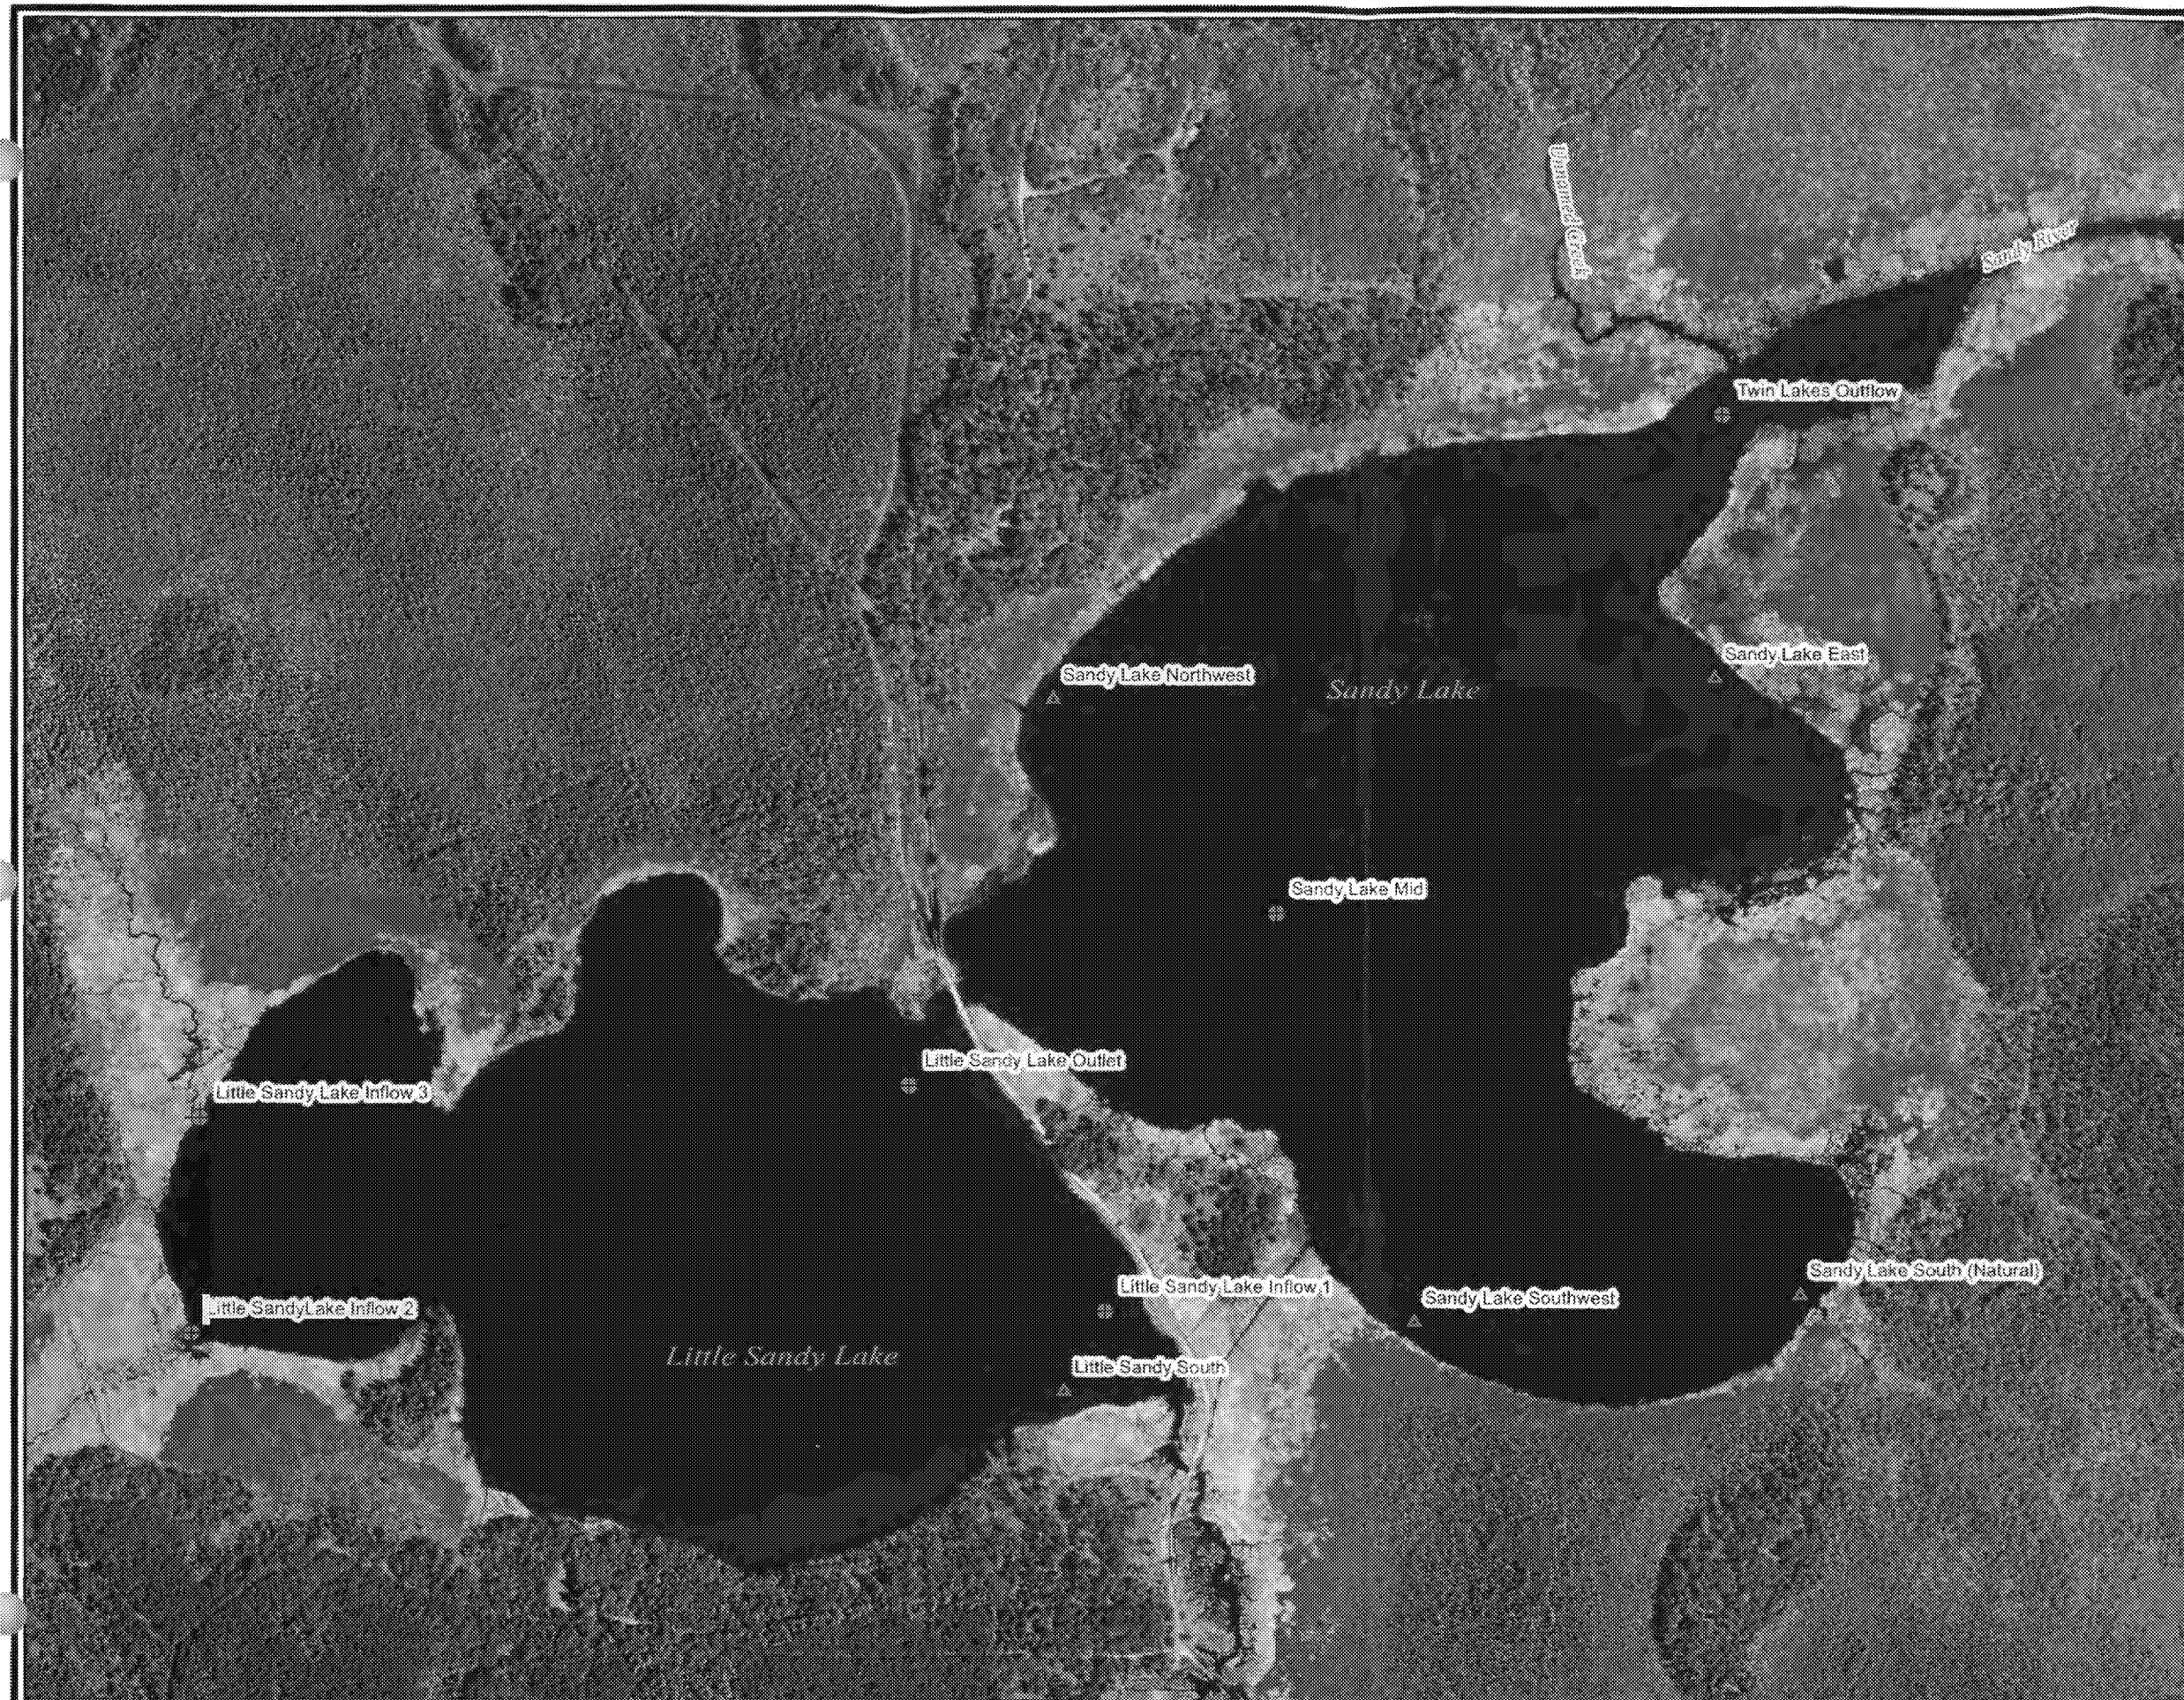
Figure 1
2016 Peeper
Deployment Locations

During the 2016 field season, six peepers were deployed in the Twin Lakes; two in Sandy Lake and four in Little Sandy Lake – in the same locations as during the 2015 field season (Figure 1). Peepers were deployed for four, one-month durations: April – May; May – June; June – July; and July – August 2016. In addition to these pore water samples, peepers were deployed for one-month durations in locations in each lake where wild rice was observed growing in test plots seeded in October 2015 (Figure 1). These above-and-beyond peeper deployments were completed to characterize sediment pore water within observed wild rice growth areas; with specific emphasis on hydrogen sulfide and extractable iron.

changes in sediment pore water as distance from inflows increased, and measure pore water characteristics at the outflow from the Twin Lakes system (Figure 1). The 'Little Sandy Lake Out,' and 'Sandy Lake Mid' peeper locations were chosen to measure sediment pore water characteristics in a location that also had a sufficient penetrable depth of sediment for secure peeper deployment. Three, one-month deployments of each of the six peepers were completed: July – August; August – September; and September – October 2015. Peepers were constructed to obtain representative sediment pore water samples from the top 10 cm of sediment; approximately 200 mL of sample were obtained from each peeper during each deployment.

During 2016, the highest sediment pore water hydrogen sulfide concentrations were measured from samples obtained at the Inflow 2 monitoring location. Concurrently, the lowest extractable iron concentrations were measured in samples also obtained at this monitoring location. These data tend to indicate that as hydrogen sulfide is produced in the pore water, available iron is bound as iron sulfide; thus decreasing the pore water extractable iron available to bind with (hydrogen) sulfide. The increasing hydrogen sulfide concentrations throughout most of the summer suggest that hydrogen sulfide generation exceeded the available iron for iron sulfide formation at this monitoring location.

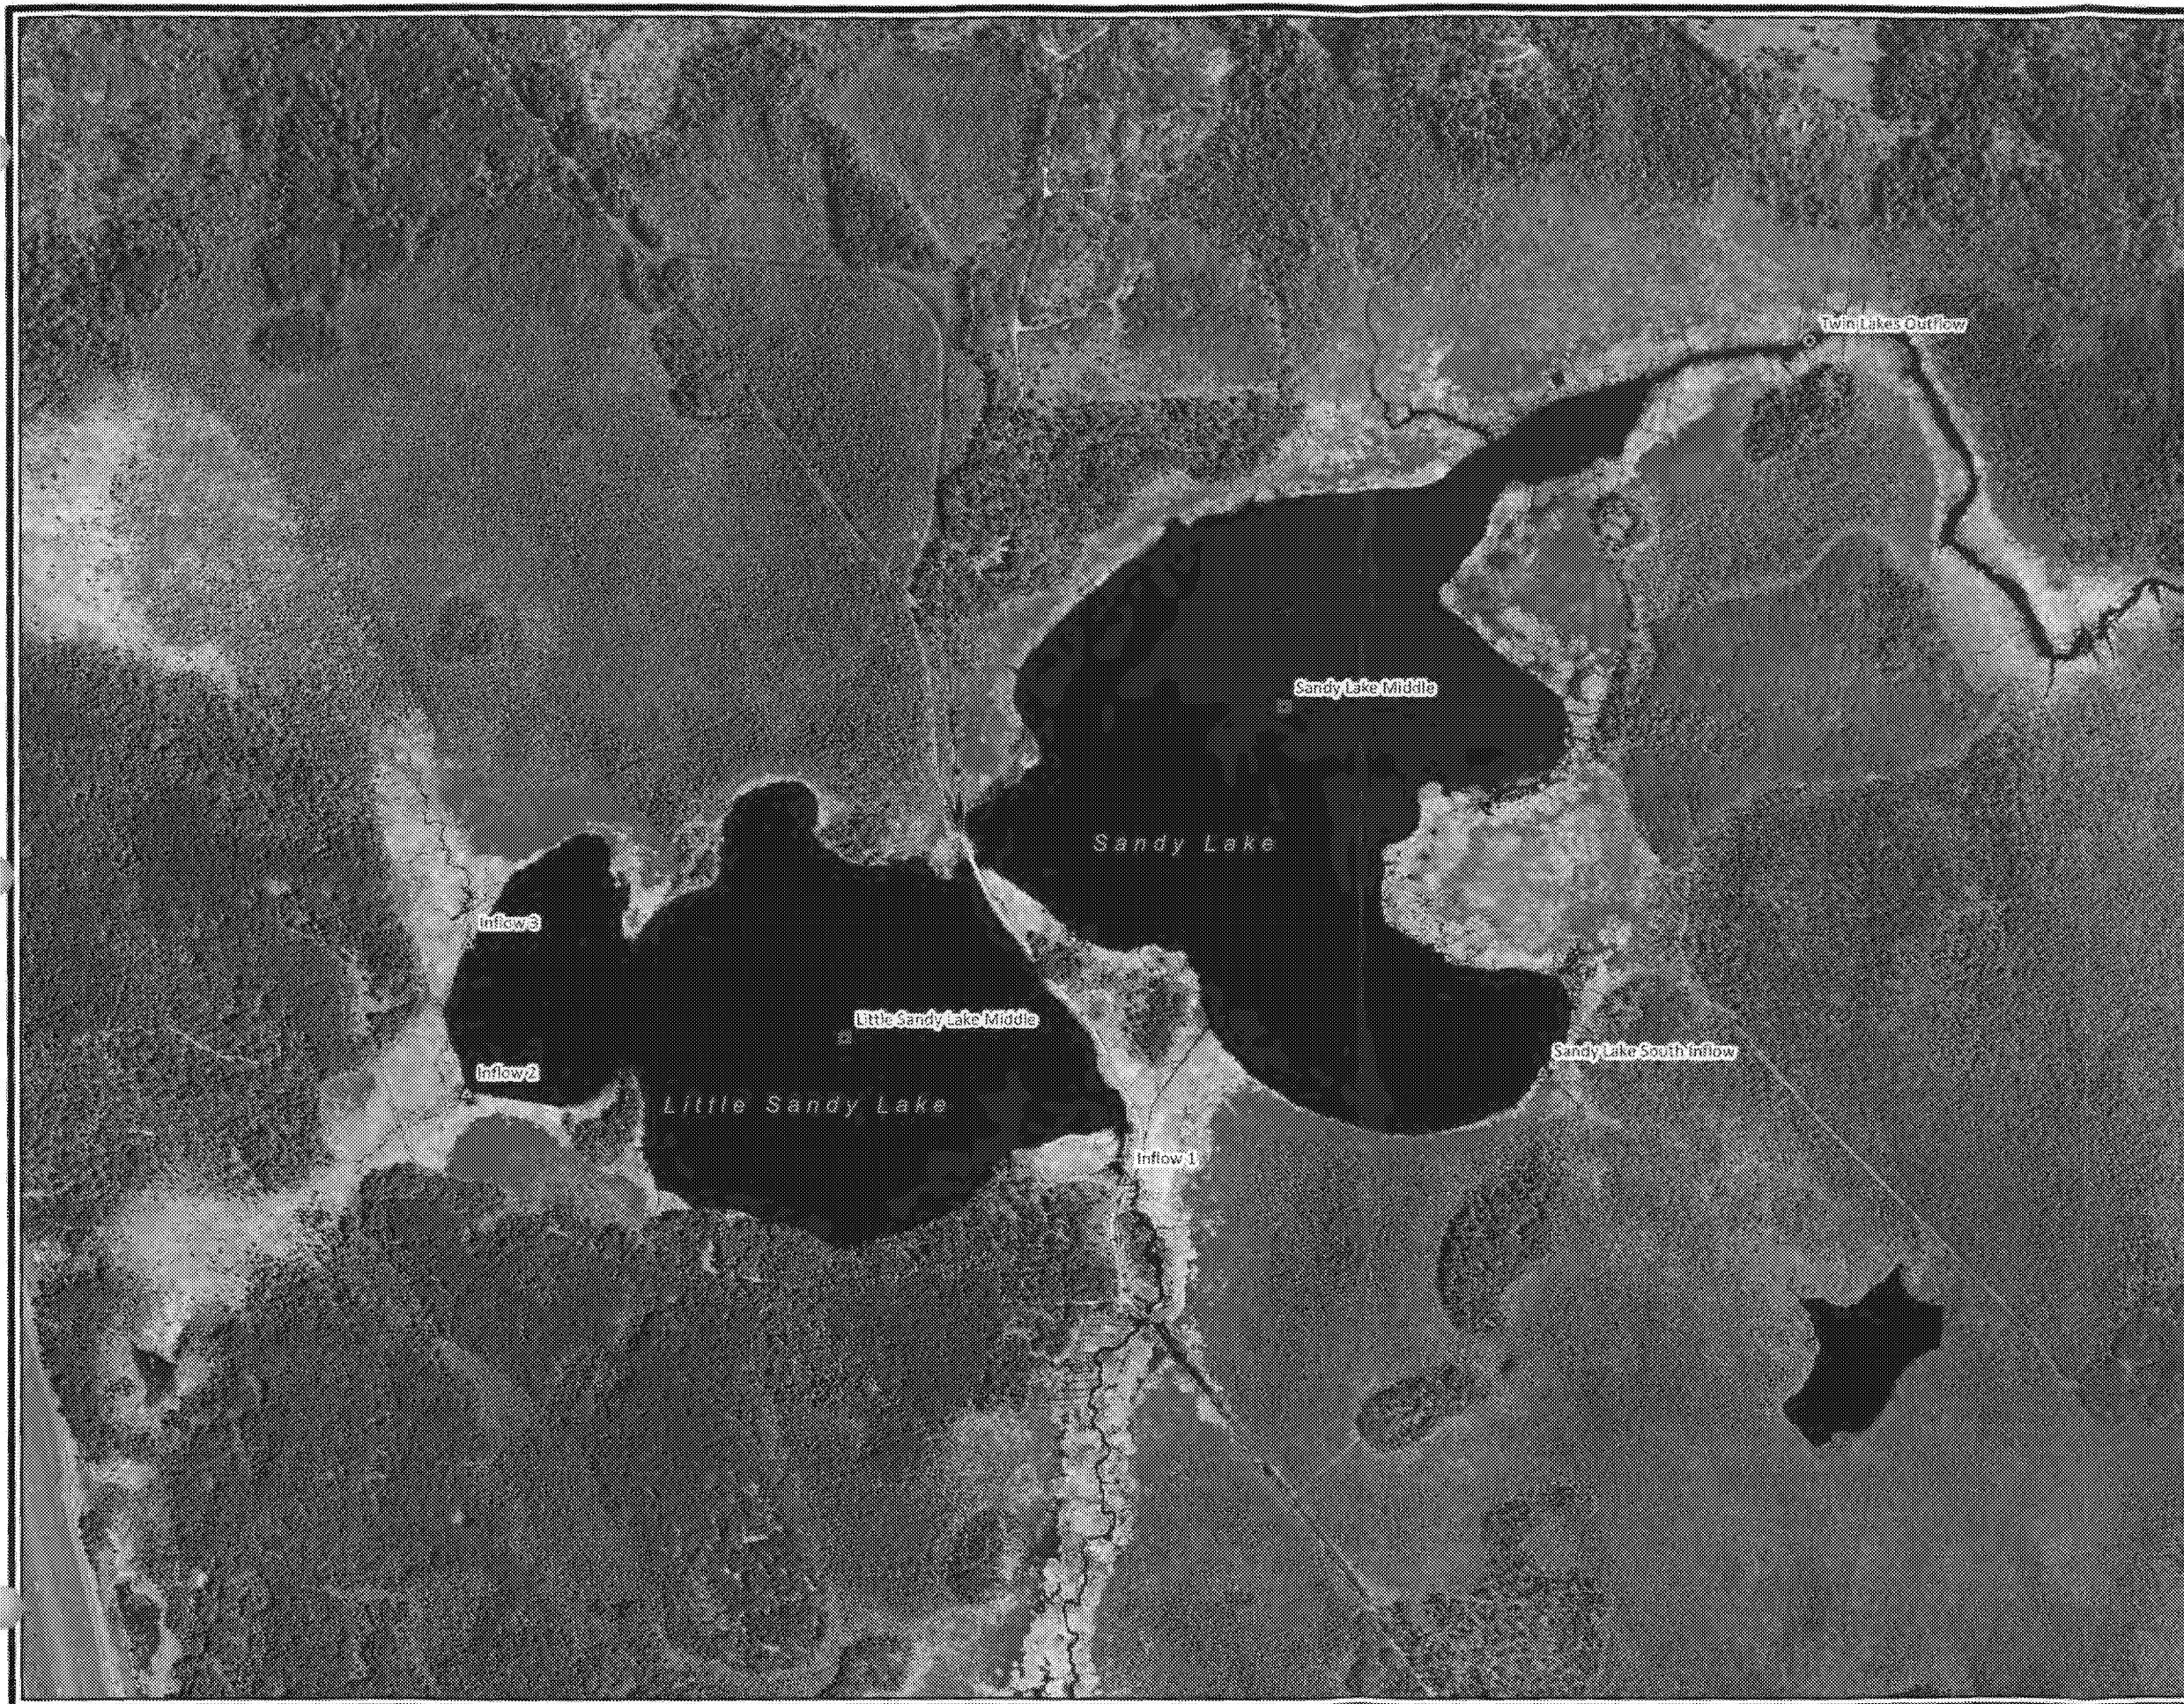
Figure 3
Twin Lakes 2016 Inflow/Outflow
Water Sampling Locations

(see Figure 3) included the inflows to Little Sandy Lake, a tributary to Sandy Lake from the north (Culvert Inflow), another tributary to Sandy Lake from the south (Sandy Lake South Inflow), and the Twin Outflow). It should be noted that the inflow samples collected above were collected either from active, measurable inflow (Inflow 1, the Culvert Inflow and the Sandy Lake South Inflow) or from areas at the periphery of the lake in close proximity to what appears to be inflow channels from aerial photos (Inflow 2 and Inflow 3). The Inflow 2 and Inflow 3 "channels" were not accessible by canoe during 2016 due to reduced water levels and/or vegetation, and therefore, samples were collected at the mouth of the inflow channels. Water was also sampled periodically from the center of each lake. These samples were collected to evaluate the general water quality of the sampling sources, with the exception of the lake monitoring of the Sand River inflow which corresponds to the discharge of the Sand River into Lake. Water quality samples are collected from the inflow channel crossing the bridge crossing the Sand River inflow into Lake. A wooden suspension bridge crosses the Sand River inflow into Lake.

Figure 3: Map of the Twin Lake system showing the locations of the inflows and outflows. The map includes labels for the Twin Lake system, Little Sandy Lake, Sandy Lake, and the Sand River. The inflows are labeled as Inflow 1, Inflow 2, and Inflow 3. The outflow is labeled as Outflow 1. The map also shows the location of the Twin Lake system water monitoring station.

Inflow 2 – represents flow entering Little Sandy Lake from a wetland complex to the west southwest that originates near the northeast corner of the Minntac tailings basin perimeter dike. The Inflow 2 sampling location is situated on the west side of Little Sandy Lake at the mouth of an east / west trending wetland flow channel.

Inflow 3 – represents discharge to the system from general wetlands present north of Little Sandy Lake. The Inflow 3 sampling location is situated on the northwest side of Little Sandy Lake at the mouth of a north / south trending flow channel running through this wetland complex.

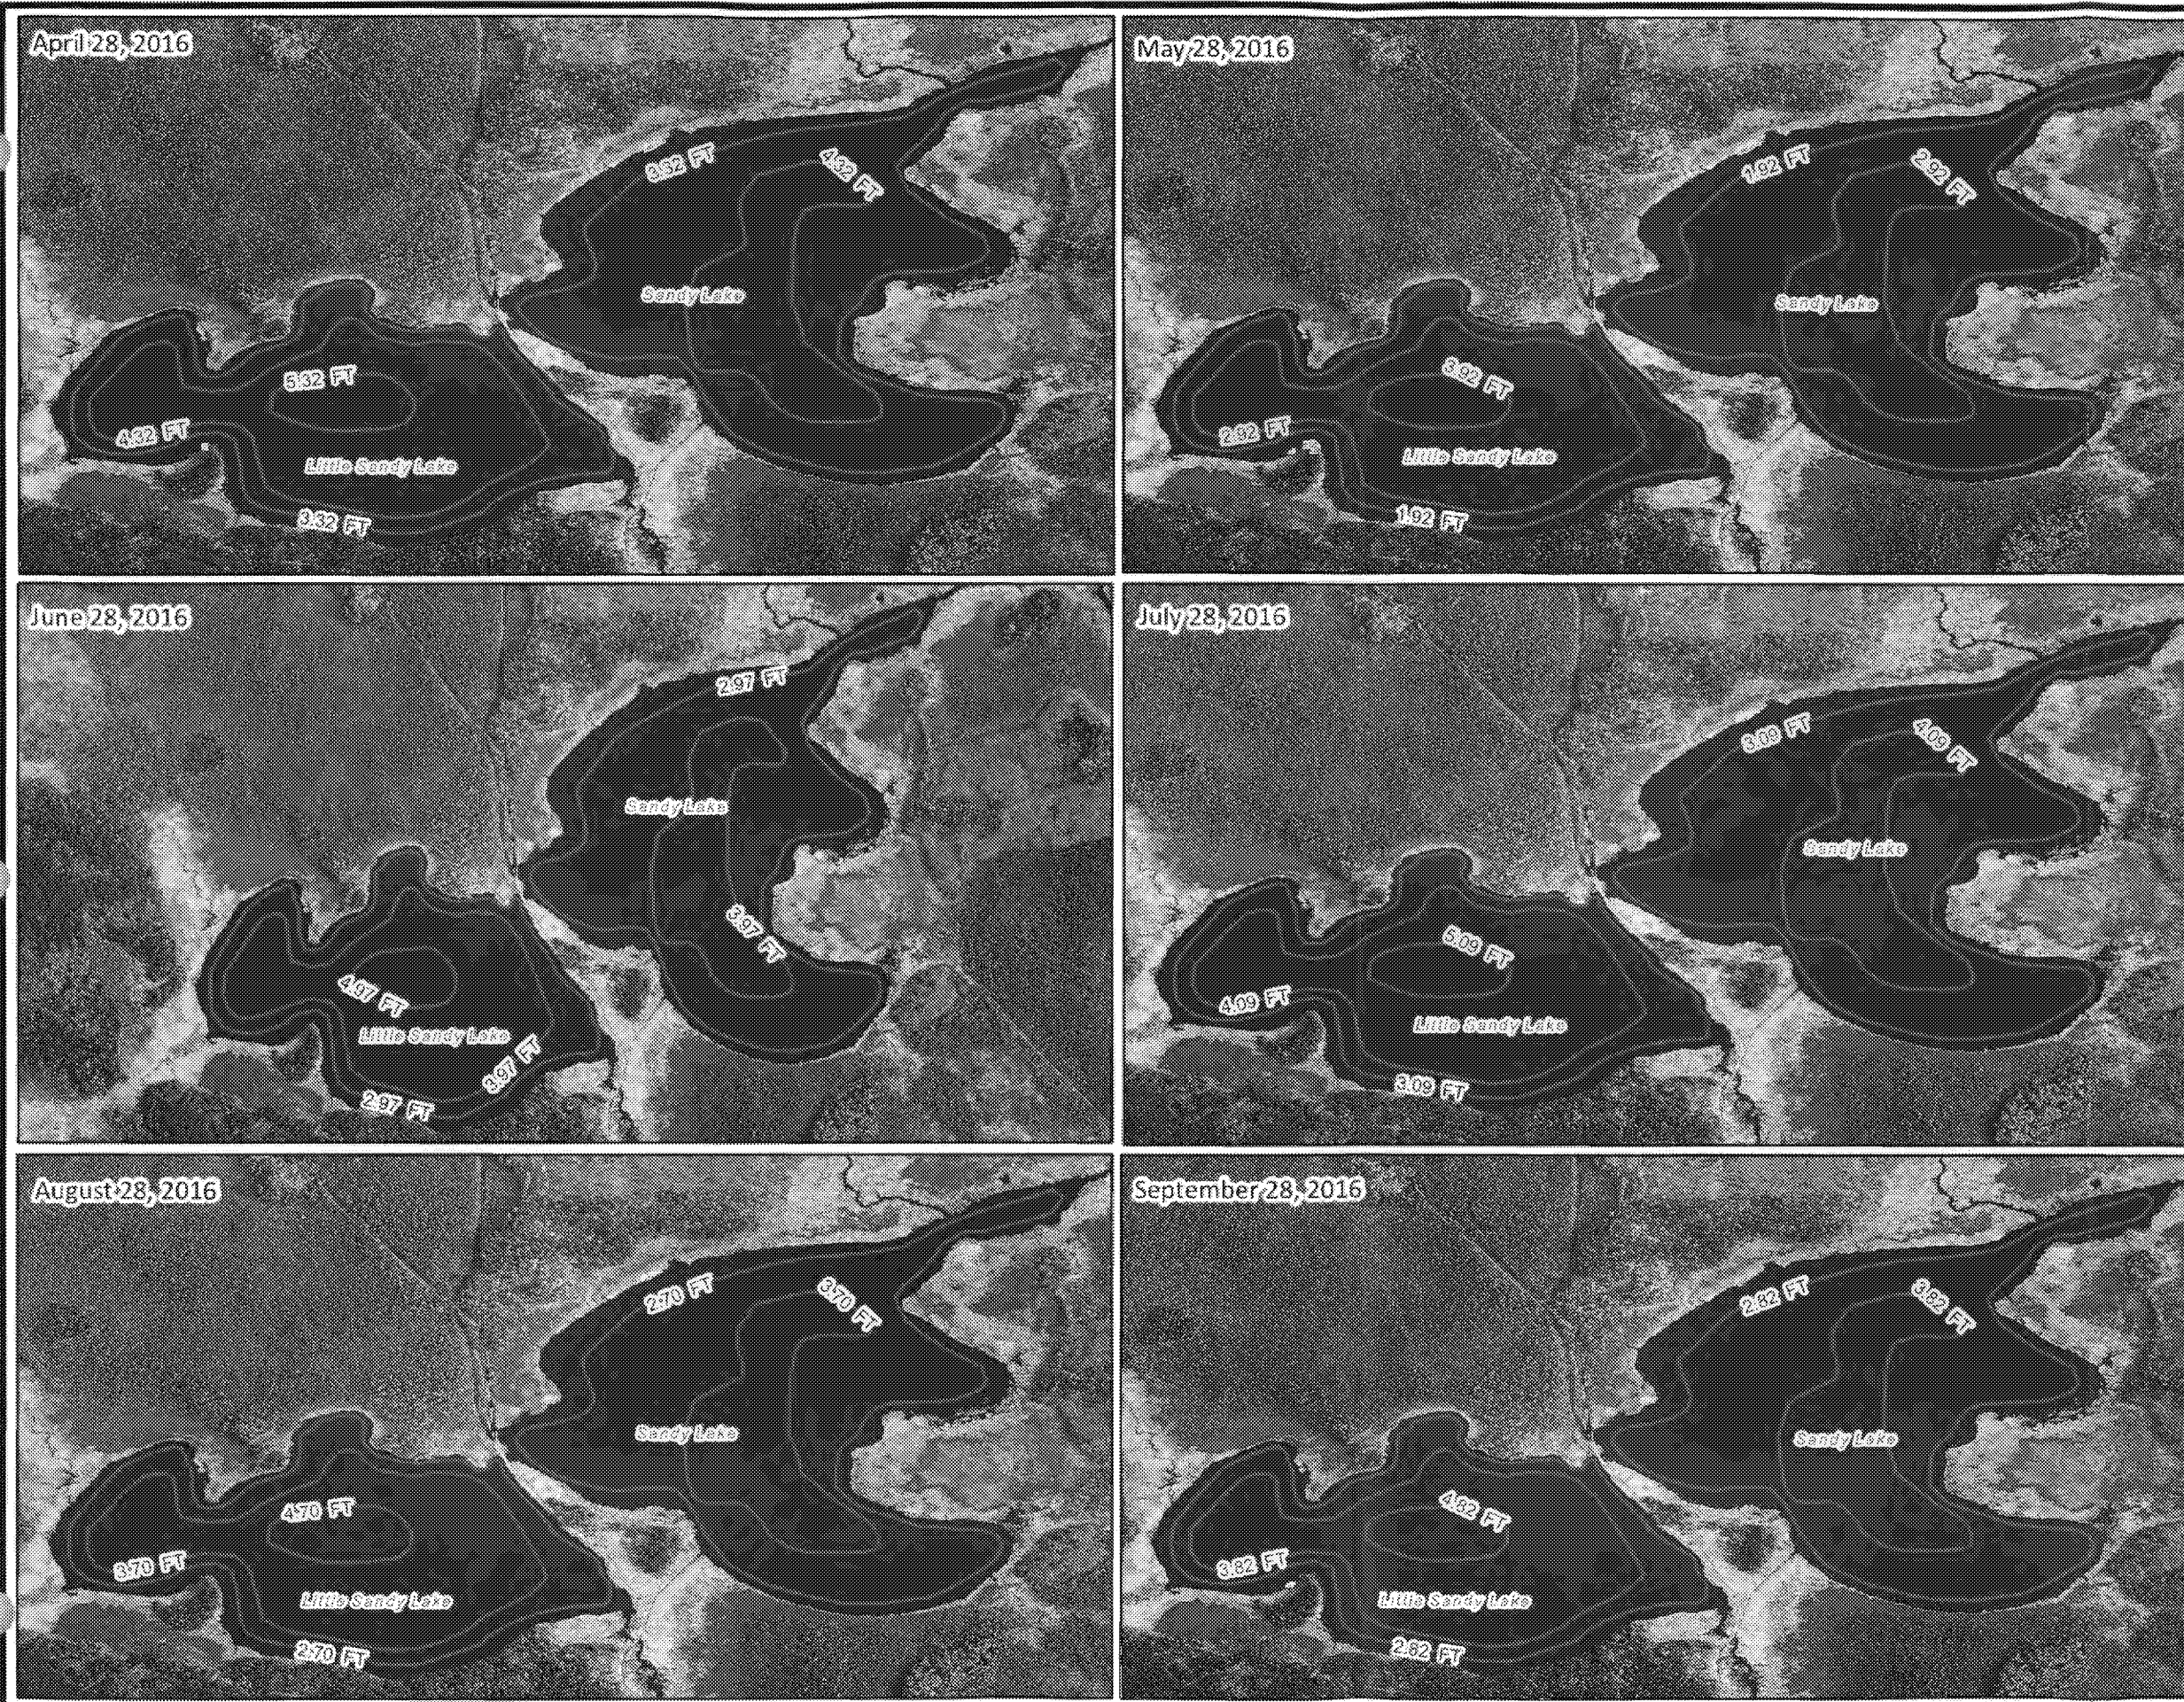
Legend
 — Twin Lakes Bathymetry

Water depth measurements obtained during the 2016 aquatic plant survey were used to construct bathymetric maps of Little Sandy and Sandy Lakes (Figure 5).

In an effort to better detail water depth fluctuations within the Twin Lakes system, six bathymetric maps of Little Sandy and Sandy Lakes (April – September 2016) were constructed using water depth measurements from the Twin Lakes bridge pressure transducer (Appendix A) and water depth measurements obtained during the 2016 aquatic plant survey. See Section 2.7 (Figure 5) for additional details.

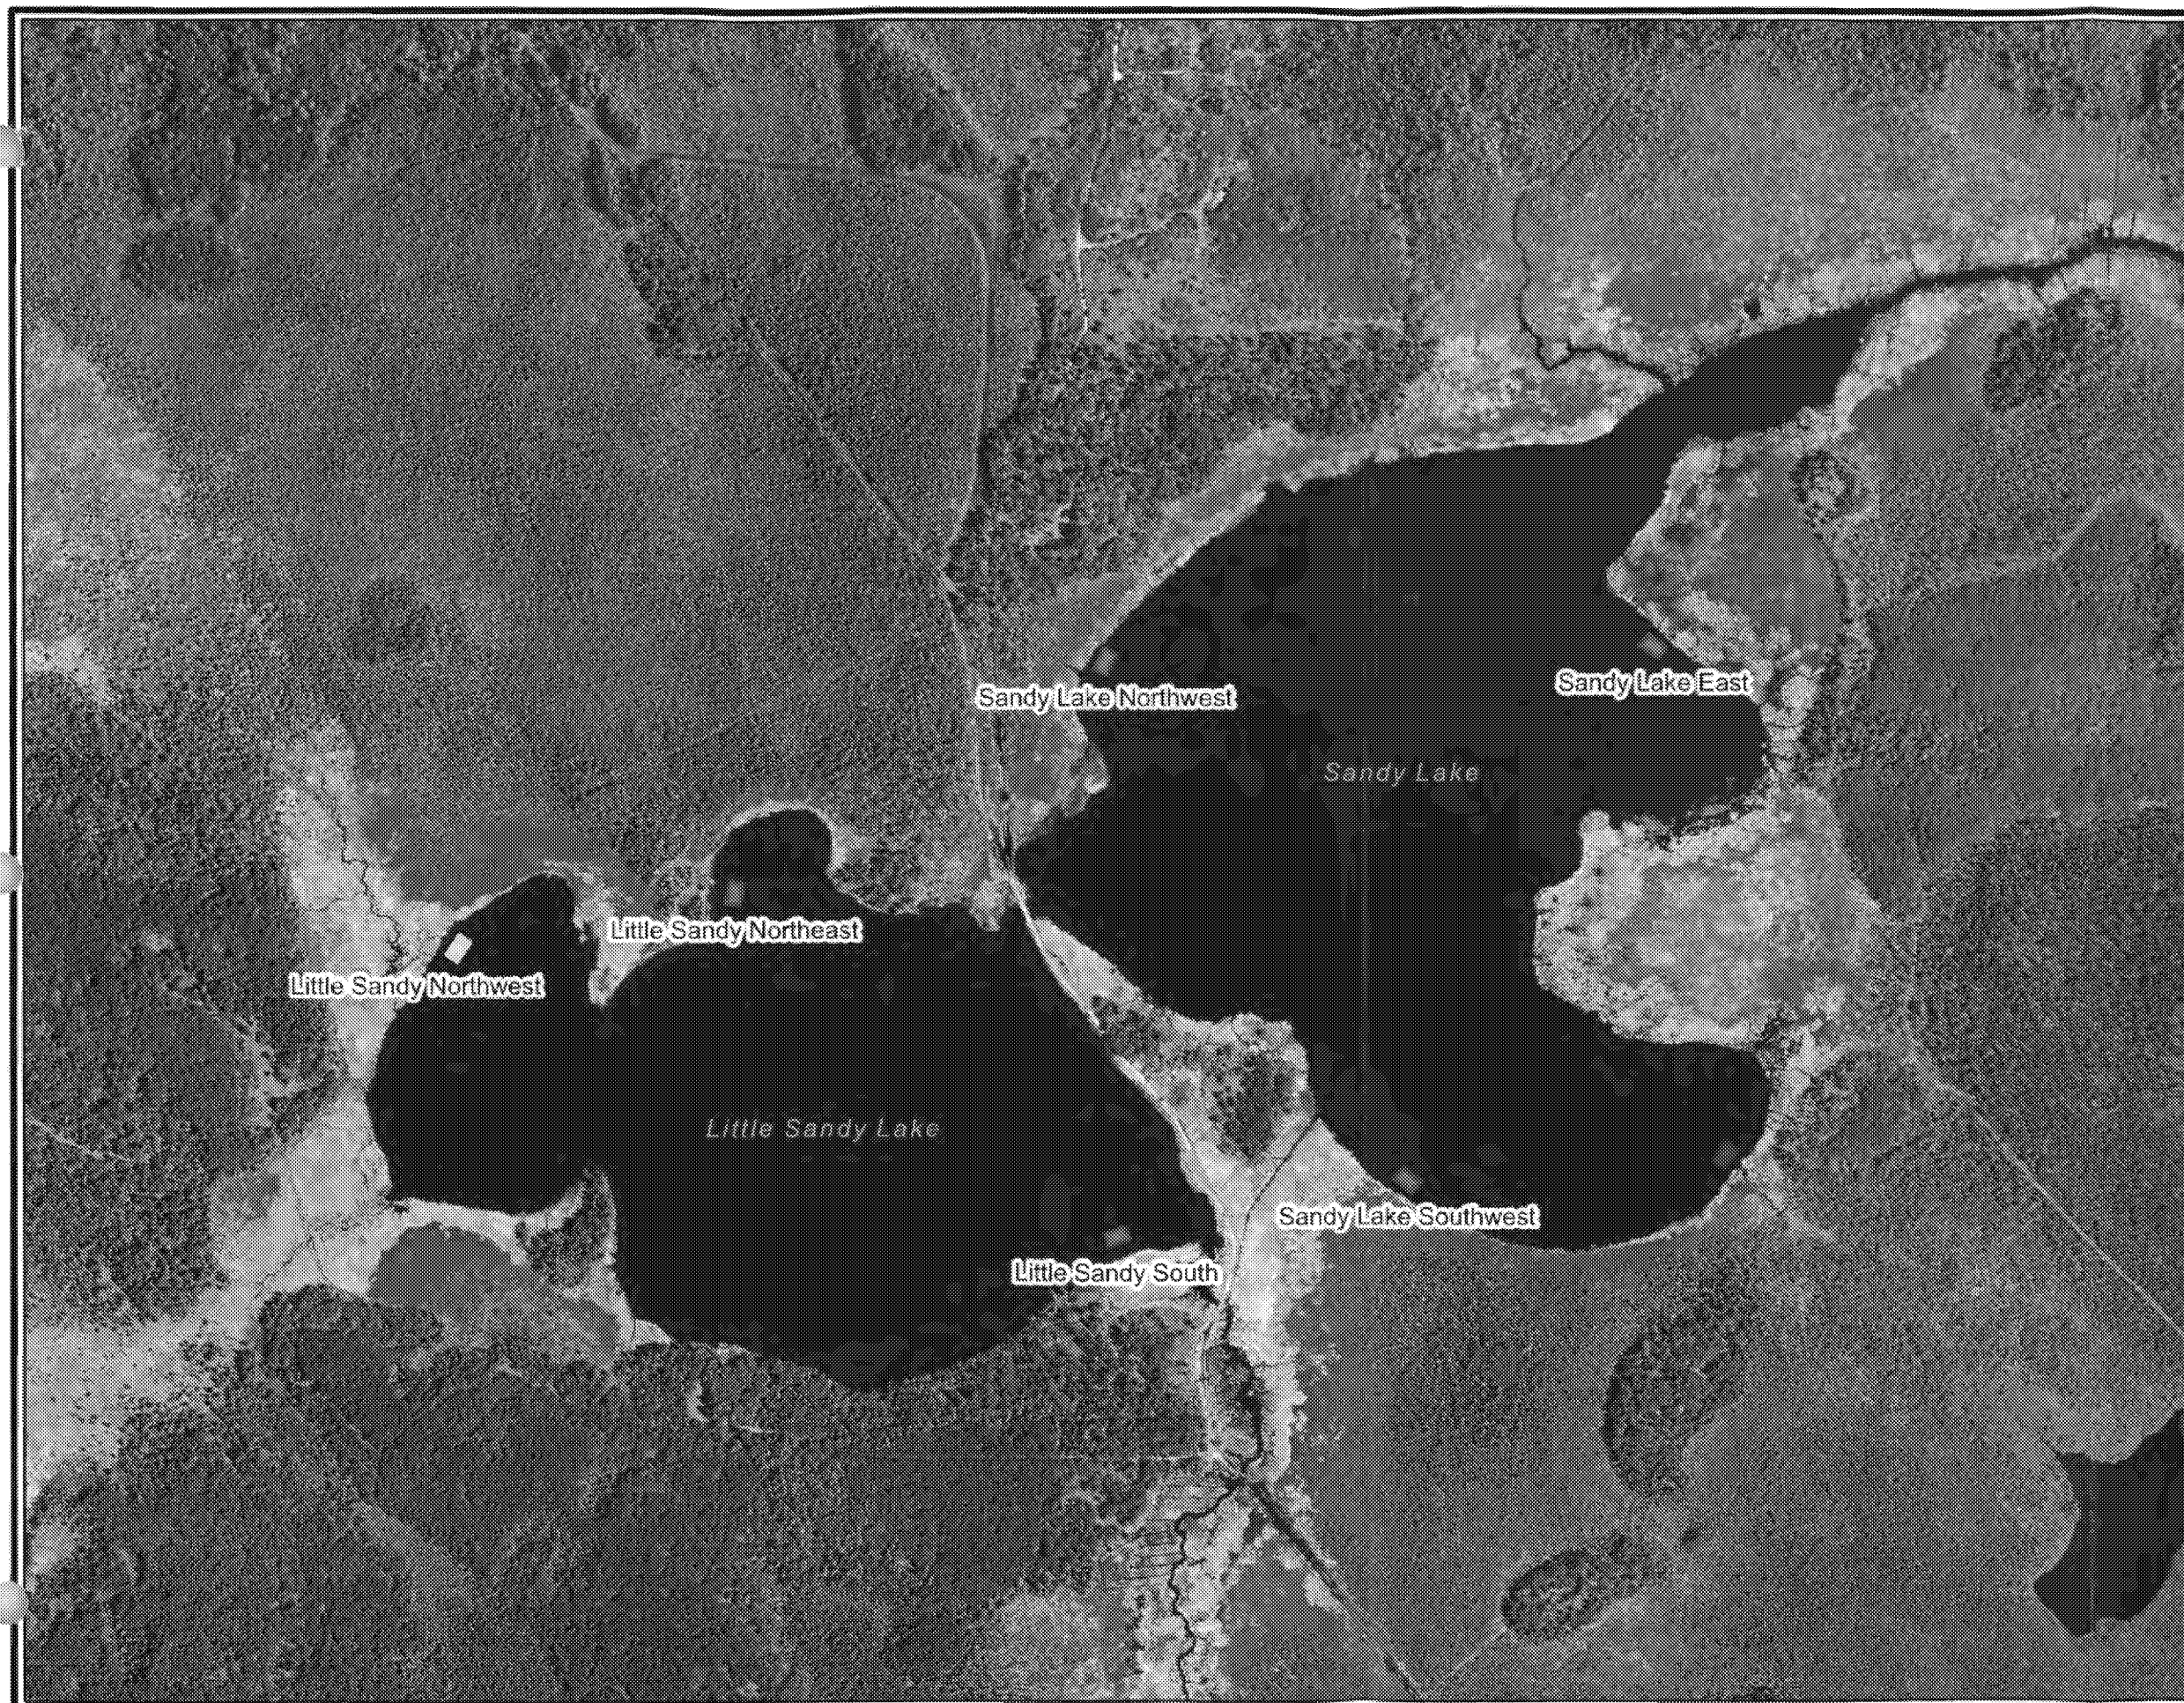
- Natural Wild Rice Growth
- Planted Wild Rice Growth
- Planted Wild Rice - No Growth

During the 2016 field season, wild rice test seeding plots were inspected for growth of WR plants. Floating leaf stage WR plants were observed during July 2016; and were confirmed during August 2016. WR plants in at least the floating leaf stage were observed in all three test seeding plots in Sandy Lake. Mature, aerial, seed-producing WR plants were observed in the Sandy Lake East (SLE) and Sandy Lake Southwest (SLSW) locations with ≥ 200 plants per plot area. WR plants in the floating leaf stage were observed in the Sandy Lake Northwest location, but with only about 30 – 40 plants in the entire plot. WR plants in the SLE and SLSW locations produced a sufficient number of seeds to have the capability of limited 'self-seeding' in those areas. Observance of WR plants in these two areas during future years could indicate limited self-seeding events, or germination of legacy seed in the sediment from the 2015 seeding efforts. Also within Sandy Lake a natural group of WR plants was observed near the Sandy Lake Inflow South tributary location. These plants were not part of the WR seeding effort, and were classified as a natural WR stand. These plants were also mature, seed producing plants capable of a limited self-seeding event in the area. It was estimated that a total of 15 – 20 natural wild rice plants emerged into aerial phase near the mouth of the Sandy Lake Inflow South tributary.

Three plots were also seeded with WR in Little Sandy Lake. The test plot near 'Inflow 1' contained ≥ 100 mature, seed producing WR plants. Similar to seed producing plants in two plots in Sandy Lake, seed producing plants in Little Sandy Lake had the capability for a limited self-seeding event in that area / plot. Sparse floating leaf WR plants were observed in the Little Sandy Northeast test seeding plot, with 7 – 10 plants observed in the entire area. No WR plants were observed in the Little Sandy Lake test seeding plot near 'Inflow 3' (Little Sandy Northwest).

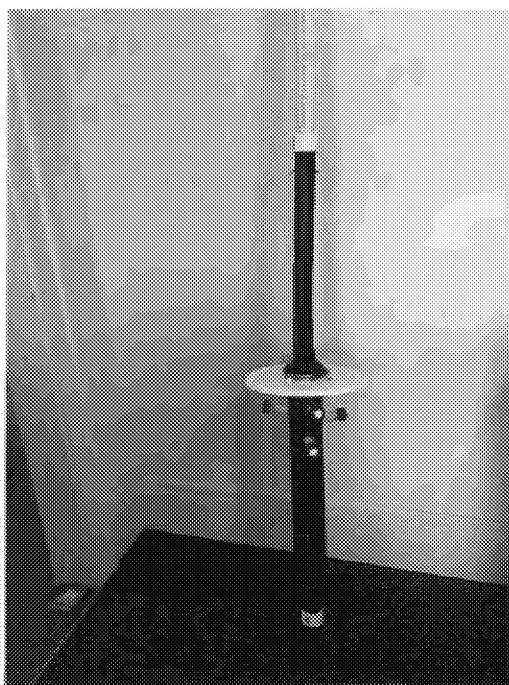
Figure 7. Peeper sediment pore water sampling device.

In order to maintain consistency of measuring characteristics of Twin Lakes sediment pore water, peepers will again be deployed in specific locations within Little Sandy and Sandy lakes. Peepers (see Figure 7) are fitted with sealed 50 mL centrifuge tubes so that when deployed the centrifuge tubes are located within the top 10 cm of sediment. Each 50-mL centrifuge tube is completely filled (no headspace) with analytical standards-grade deionized water obtained from Pace Analytical Laboratories (Pace; Virginia, MN). Each tube contains a 0.45 μ M pore size filter in the cap to allow for deionized water / pore water equilibration via diffusion. Using peepers to collect pore water samples for characterization can better minimize, if not eliminate, the potential for the collected pore water to be exposed to air / oxygen.

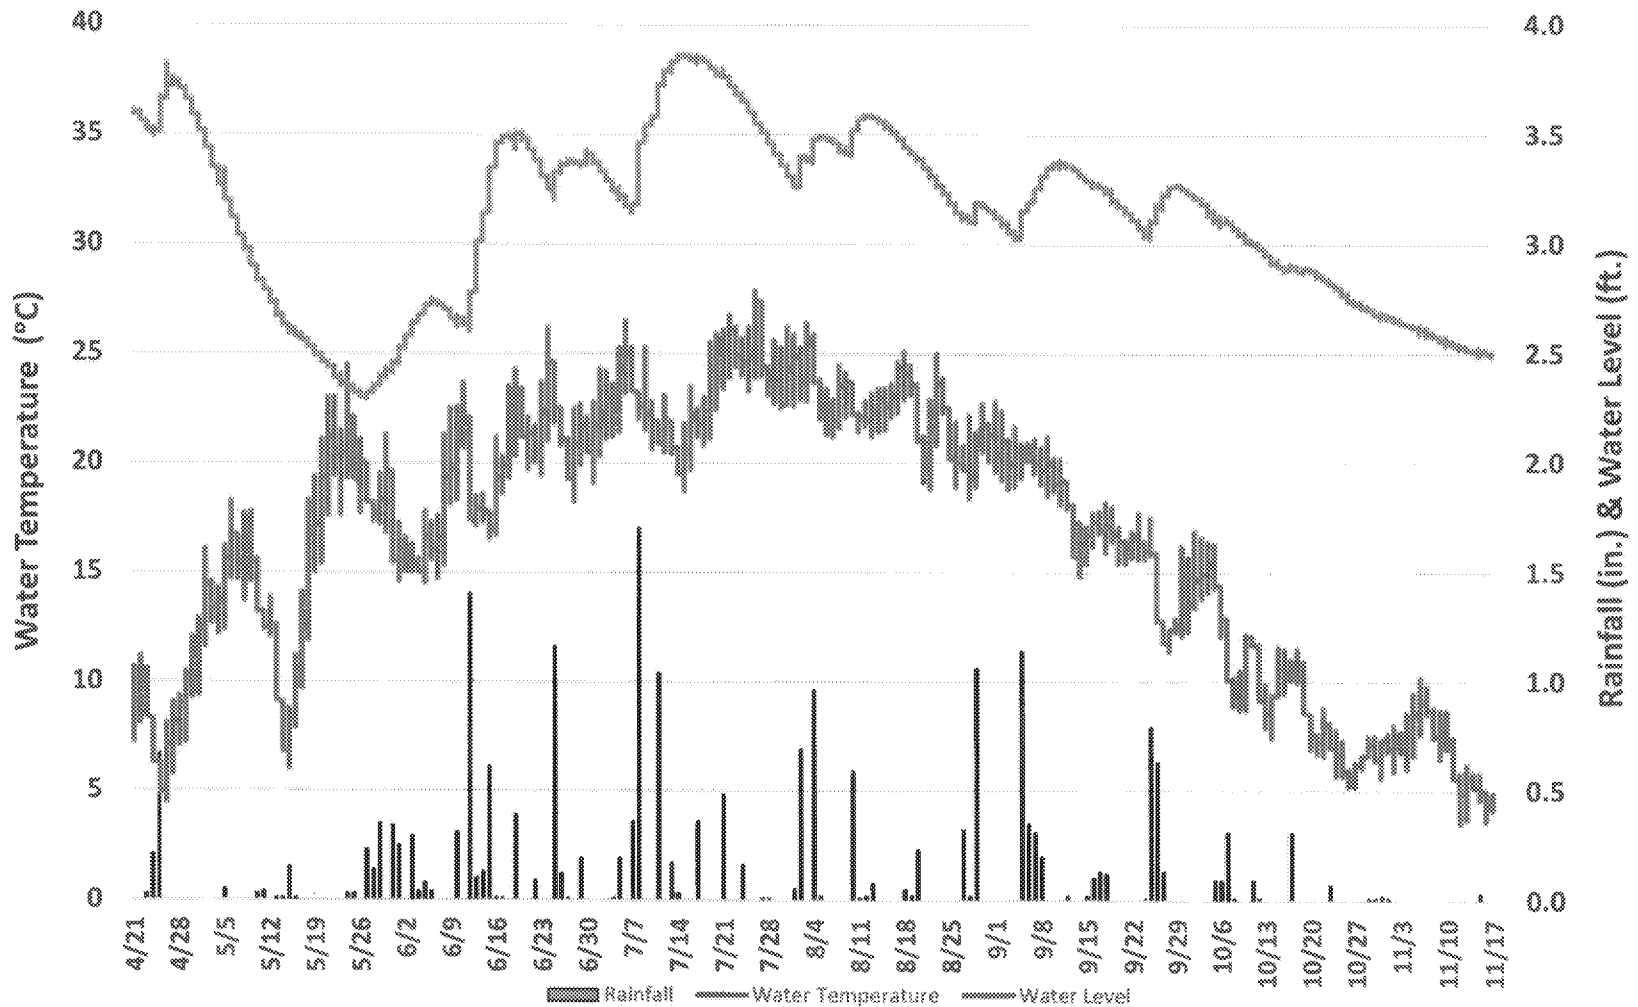
2016 Twin Lakes Water Level, Temperature & Rainfall

The graph in Appendix A does indicate that the Twin Lakes water depth is greatly affected by rainfall. The local weather service has stated that 2016 was one of the wettest summers on record and even with the elimination of the beaver along Sand River, the water remained elevated for most of the summer. There was one period, in late May 2016, where the water dropped below 2.5'. The rest of the period never saw that level again until mid-November. Further discussion concerning the water level will
